AFWAL-TR-85-4150
Volume 2

DEVELOPMENT OF FRACTURE MECHANICS MAPS
FOR COMPOSITE MATERIALS

DFVLR - Institute for Structural Mechanics
Braunschweig, West Germany

Final Report for Period January 1982 - January 1985

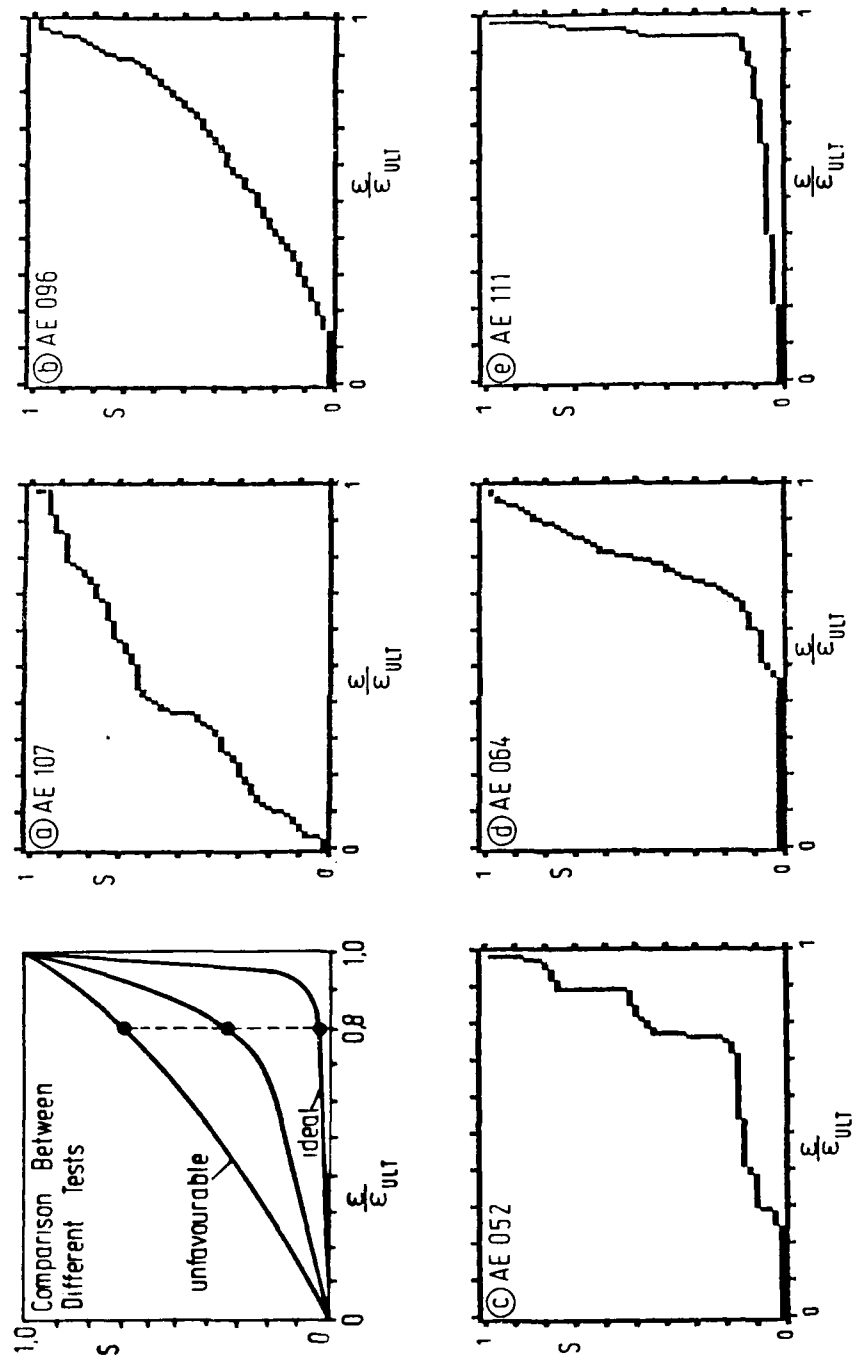
Fig. 11.22 Cumulative acoustic energy output S during loading of CFRP-rings by internal pressure.

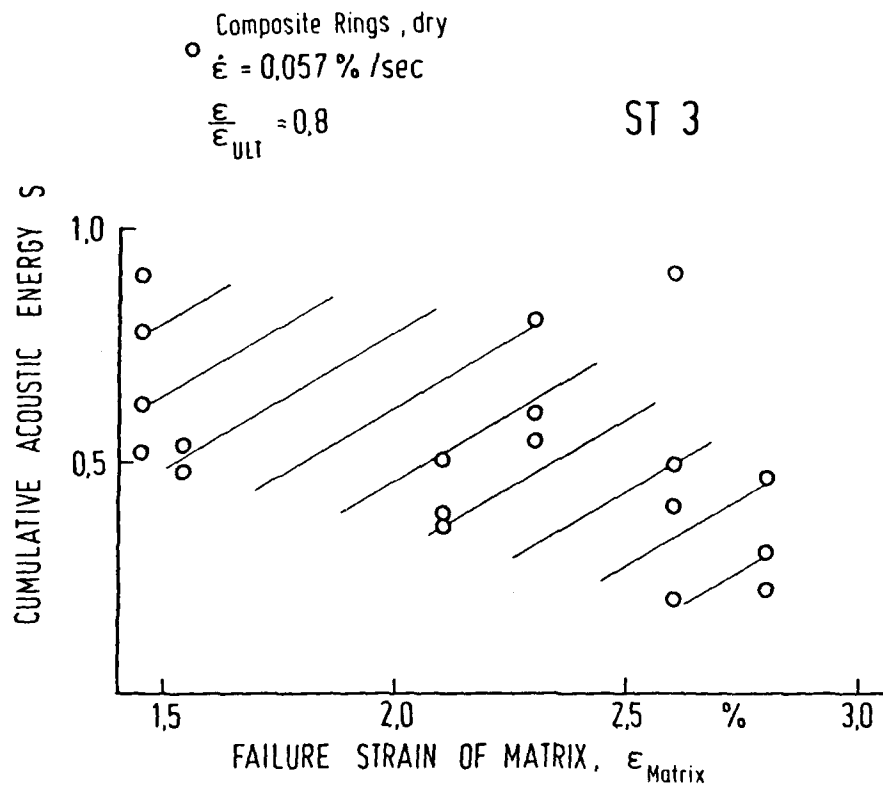
Fig. 11.23 Cumulative acoustic energy output of CFRP rings with different matrices at 80% of failure stress. (The shaded area represents a general tendency found in the entire set of tests with ST 3)

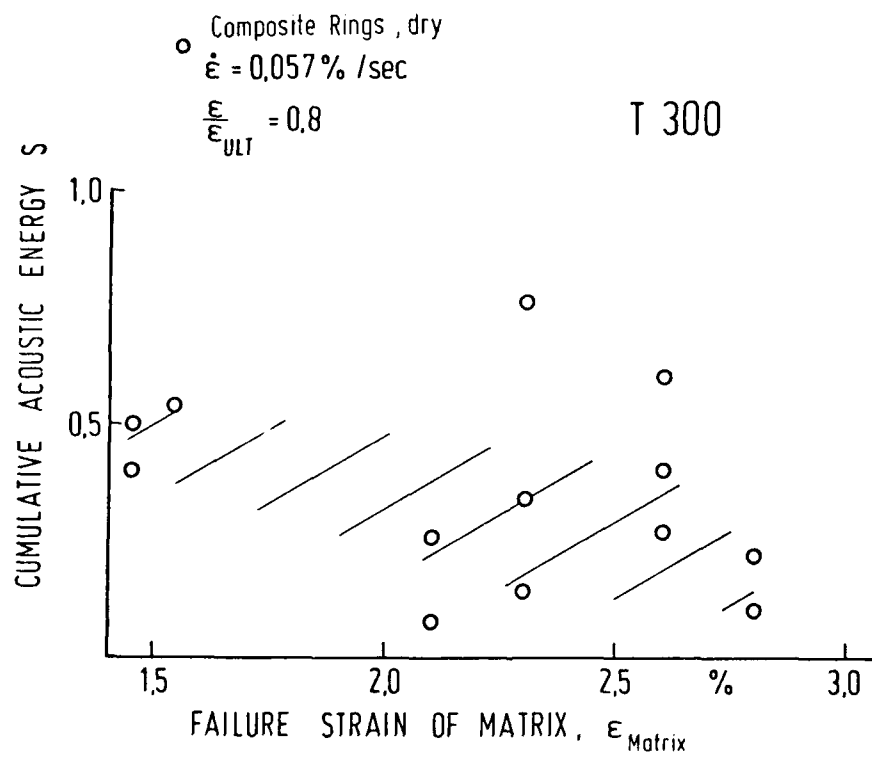
Fig. 11.24 Cumulative acoustic energy output of CFRP rings with different matrices at 80% of failure stress. (The shaded area represents a general tendency found in the entire set of tests with T 300)

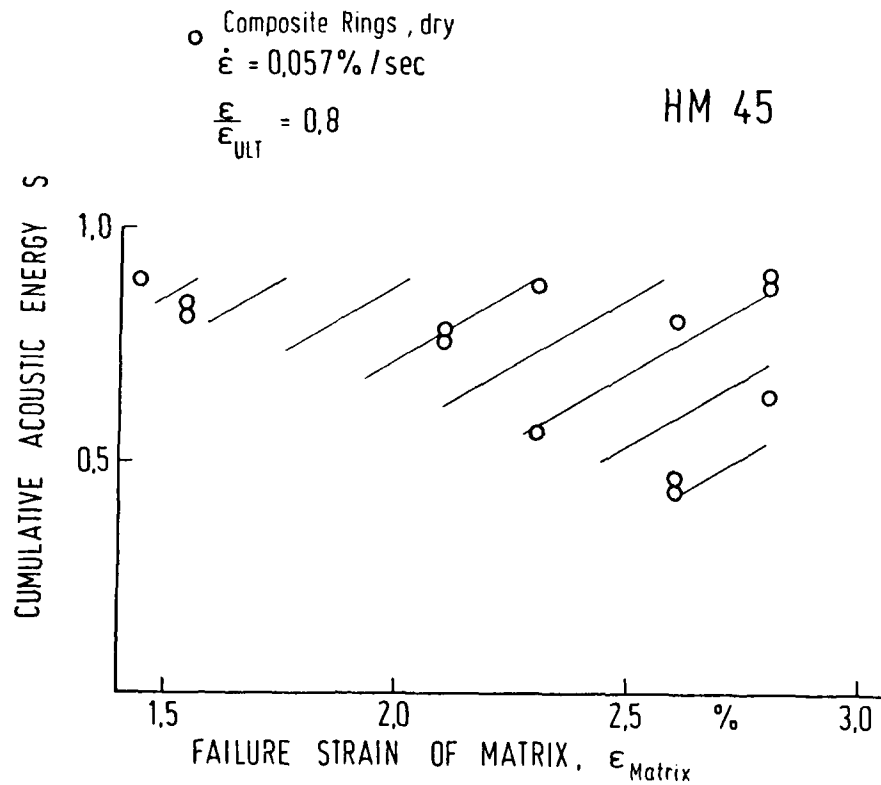
Fig. 11.25 Cumulative acoustic energy output of CFRP rings with different matrices at 80% of failure stress. (The shaded area represents a general tendency found in the entire set of tests with HM 45)

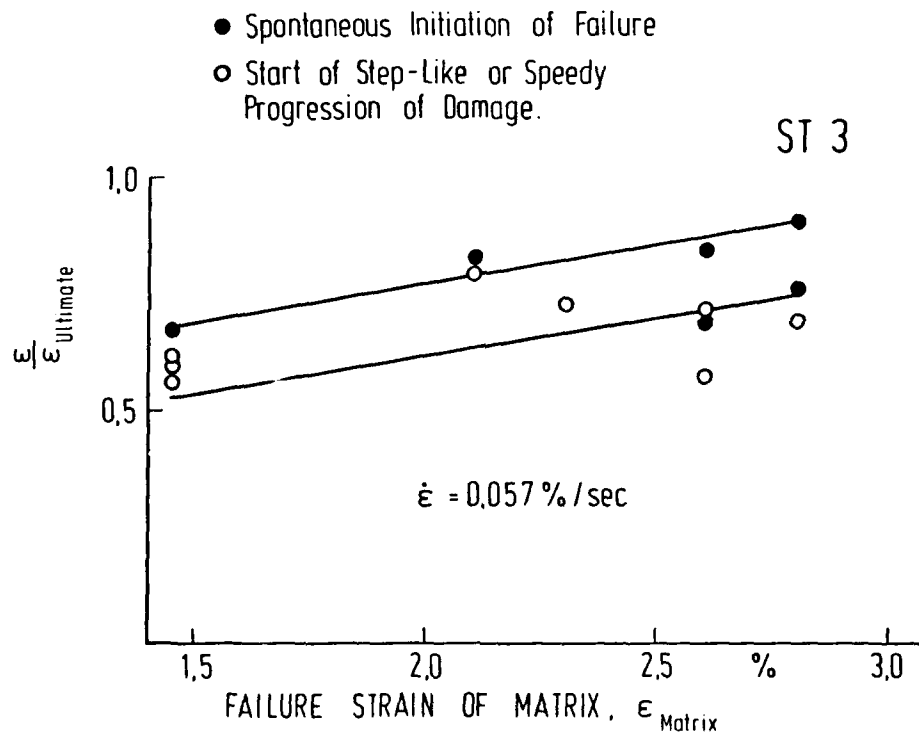
Fig. 11.26 Range of spontaneous initiation of failure in CFRP rings determined by acoustic energy output.

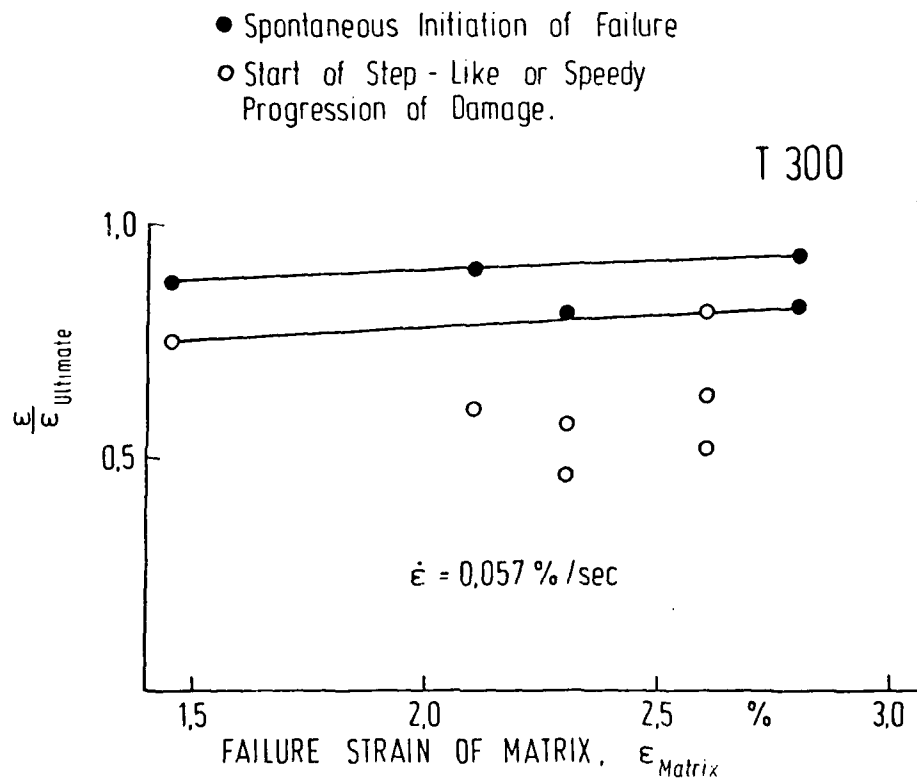
Fig. 11.27 Range of spontaneous initiation of failure in CFRP rings determined by acoustic energy output.

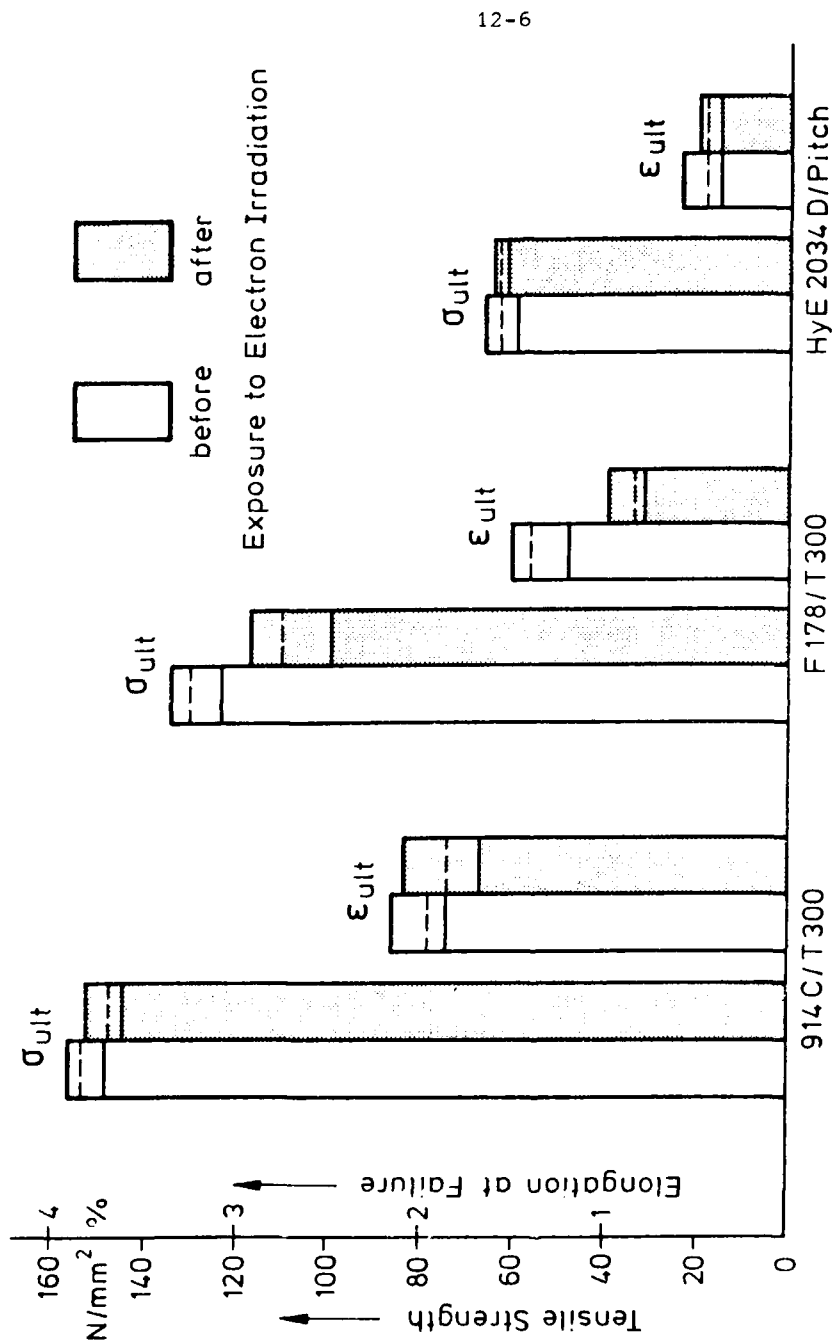
Fig. 12.1 Degradation of the mechanical properties due to electron irradiation.

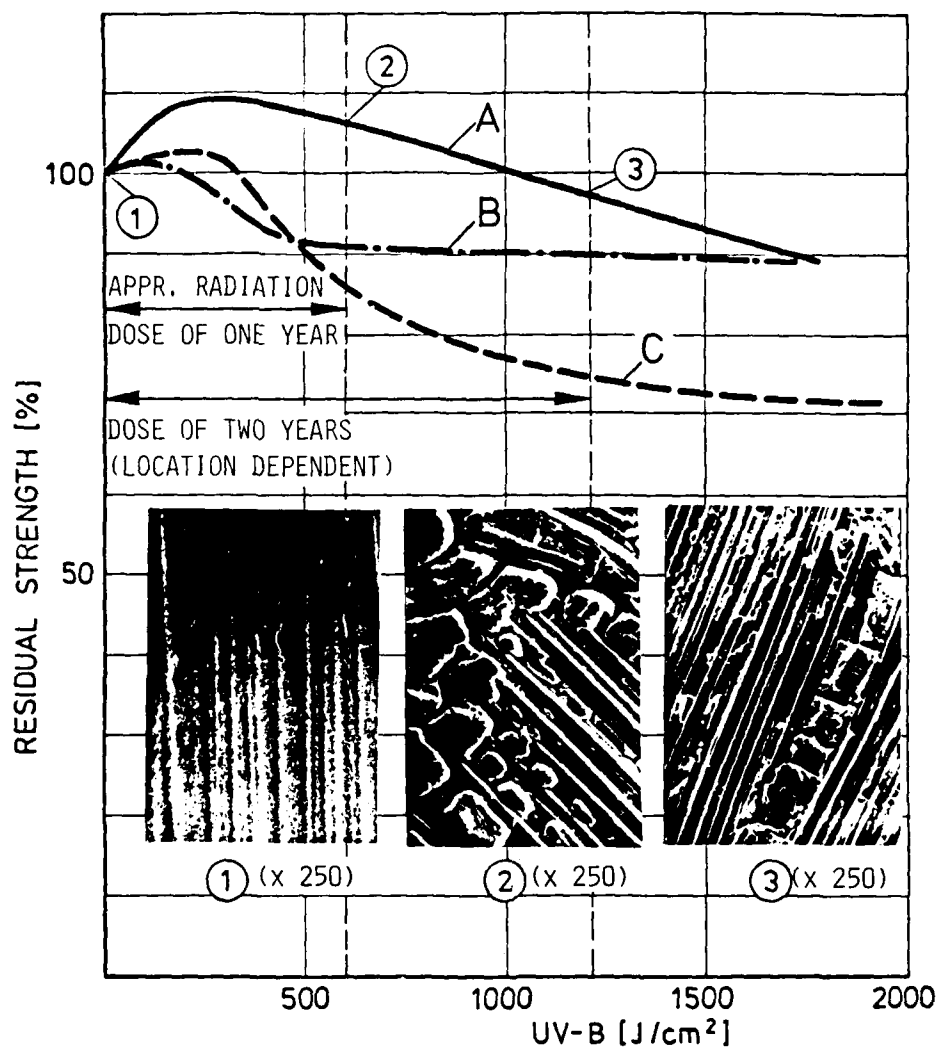
Fig. 12.2 Degradation due to UV-B Irradiation,

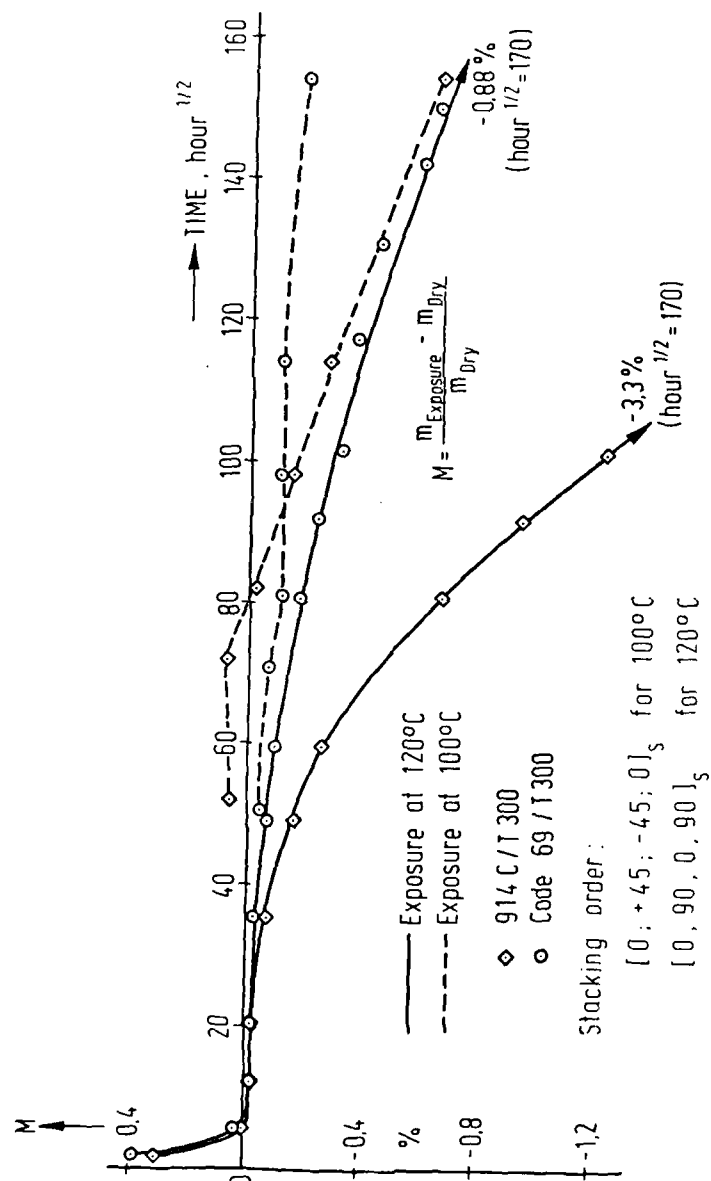
Fig. 12.3 Weight loss of carbonfiber-reinforced epoxy resins during long time exposure in air at 100°C and 120°C.

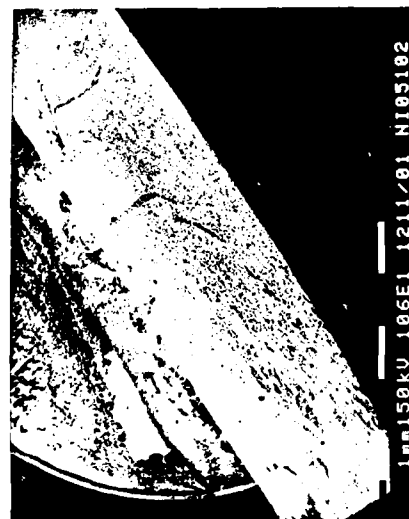
Epoxy resin BSL 914; fracture surfaces of tensile test specimens.

Figs. 13.1 through 13.10 display fracture surfaces of Ciba BSL 914 test specimens subjected to tensile loads. The data line at the bottom of the figures contains, as the third entry, the magni-

fication in exponential form, i.e., the designation 1.06 E1 in Fig. 13.1 signifies a magnification of 10.6. The odd-numbered figures display the fracture surfaces of dry test specimens under increasing magnification and the even-numbered the fracture surfaces of test specimens saturated at 93% relative humidity. Figs. 13.1 and 13.2 show the fracture surfaces of dry and moist specimens magnified ca.10. Already here different patterns of elevations and suppressions are noticeable which become more pronounced at magnification 50 in Figs. 13.3 and 13.4, indicating different degrees of ductility. In the upper half of Fig. 13.4 fracture parabolas can be recognized similar in appearance to those occurring at high static loads in metals. The fracture surfaces of the dry specimen with their flat and uniform topography, in comparison, signify lack of ductility in the resin. At a magnification of 500 (Figs. 13.5 and 13.6) the fracture surfaces have a flake-shaped appearance, more pronounced in the moist specimen and thereby supporting the contention of higher ductility of the resin in the presence of moisture. This reasoning is in accord with macroscopic measurements of the strain to failure, ϵ_{ult} , which is twice as high in the moist specimen (2.7%) than in the dry specimen (1.35%).

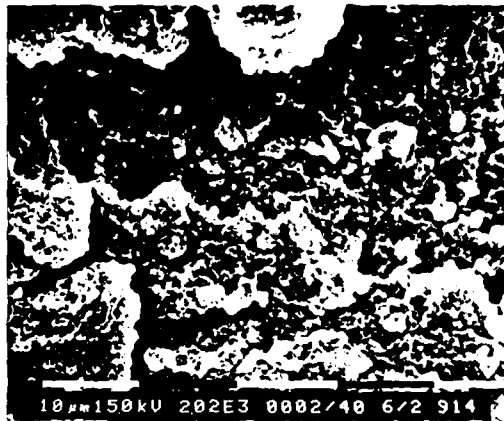
Fig. 13.15

Heating rate 0,8°C/min
up to 170°C
4h constant 170°C

Epoxy resin BSL 914. Fracture surfaces of tensile test specimens with different curing cycles.

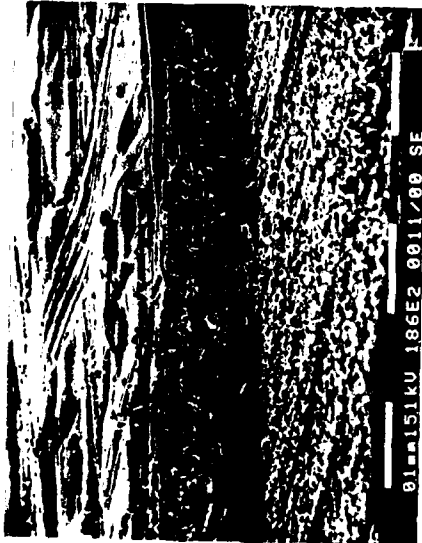
Fig. 13.20

914C-TS-5 laminates, $[\pm 45^\circ]_{2s}$
 Left: Without thermal cycling;

Figs. 13.20 and 13.21 show the rupture planes of a 45°-ply and part of the adjacent ply beneath it. In the non-cycled specimen many specks of the resin are still attached to the fibers over the entire extent of the microphotograph, whereas the rupture plane of the cycled specimen is much smoother. At higher magnification (Figs. 13.22 and 13.24) the resin particles are seen to still firmly adhere to the fibers. In Figs. 13.23 and 13.25 the surfaces of the fibers and their impressions in the matrix material appear quite smooth. The matrix has a rather flat topography and is more finely grained, which is indicative of embrittlement. This observation is supported by Figs. 13.26 and 13.27 which show a higher number of fiber breaks and a stronger inclination of the fiber failure plane at the cycled specimen. Corresponding macro-mechanical tests described in Section 10 support the soundness of this contention.

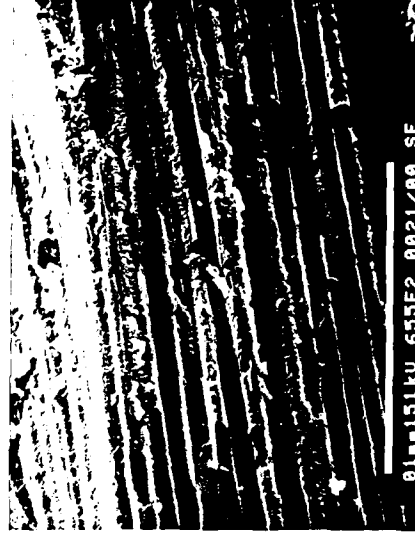
Fig. 13.23

Right: 3480 thermal cycles;

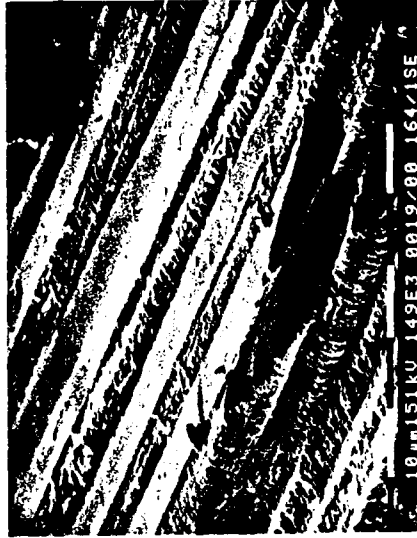
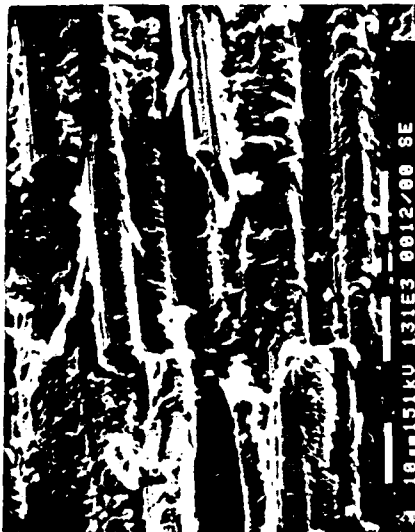
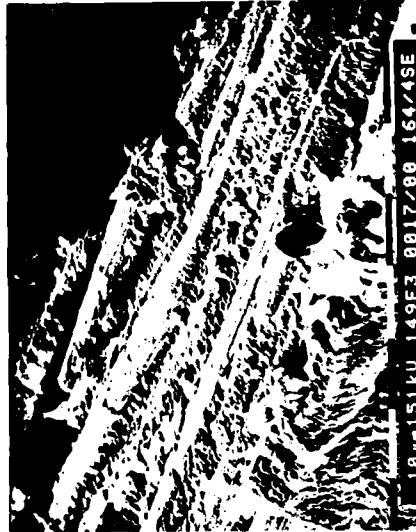
914C-TS-5 laminates, $[\pm 45^\circ]_{2s}$. Fracture surfaces of tensile test specimens.

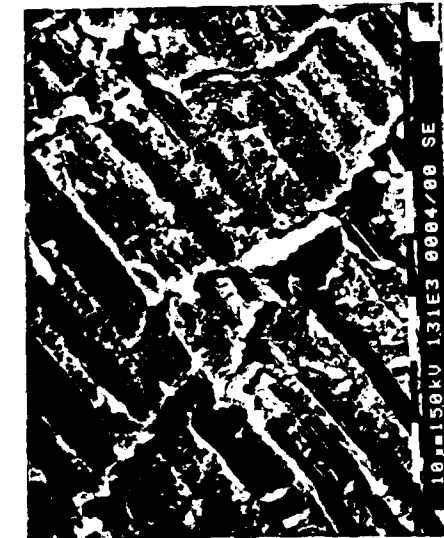
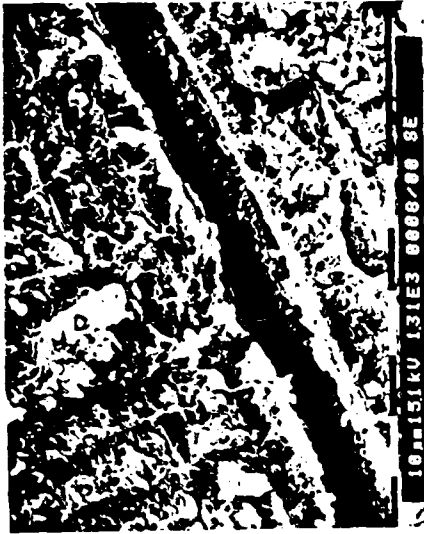
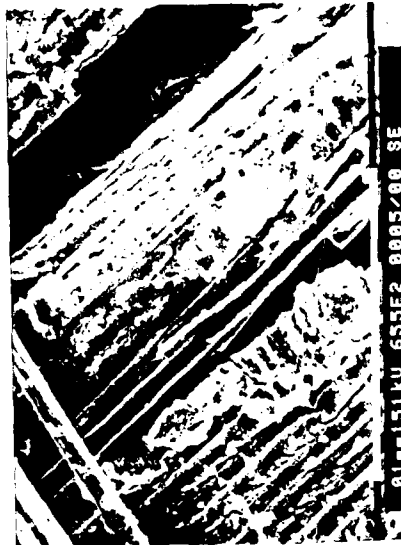
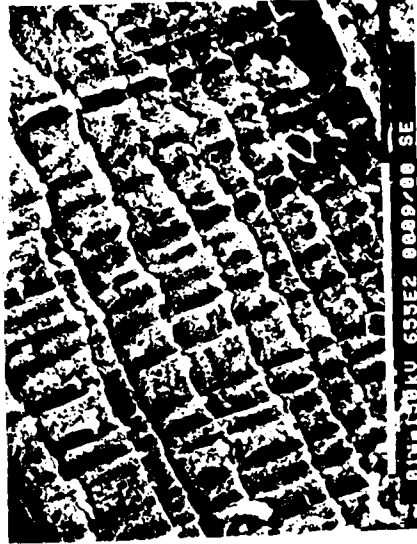
914C-TS-5 laminates, $[\pm 45^\circ]_{2s}$. Fracture surfaces of tensile test specimens.
 Left: Without thermal cycling;
 $G_{ult.} = 143,1 \text{ N/mm}^2$
 Right: 3480 thermal cycles;
 $G_{ult.} = 151,9 \text{ N/mm}^2$.

It is also of significance that the fracture surfaces of the cycled specimens have a rather flat topography and display crack patterns with smaller crack distances than those of the non-cycled specimens (Figs. 13.28 through 13.31) which may be interpreted as embrittlement of the resin due to the postcuring effect of the thermal cycling. A tendency toward embrittlement of the matrix and a weakening of the fiber-matrix interface was noted also in the other epoxy-systems referred to in Section 10. In the case of the polyimide-system, however, no degradation of the interface is evident from a comparison of the fracture surfaces of non-cycled and cycled specimens shown in Figs. 13.32 and 13.34, and in Figs. 13.33 and 13.35, respectively. An evaluation

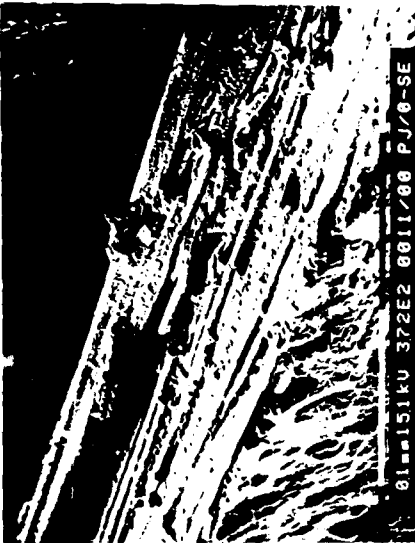
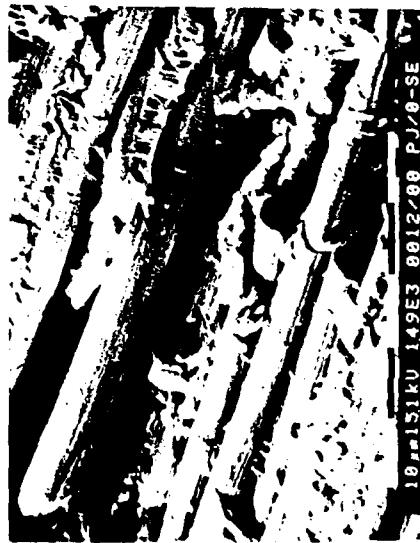
Polyimide laminates T3T-F178, $[\pm 45^\circ]_{2s}$

Left: Without thermal cycling,

$$G_{ult.} = 121,5 \text{ N/mm}^2.$$

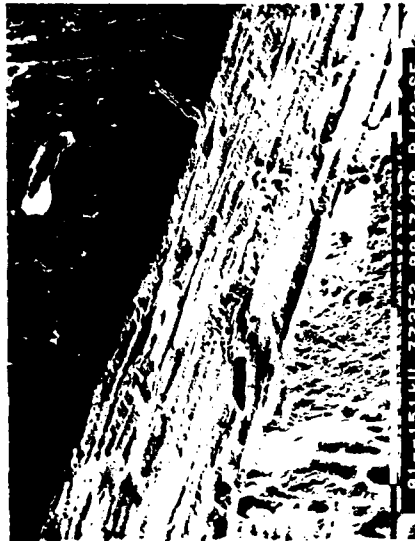
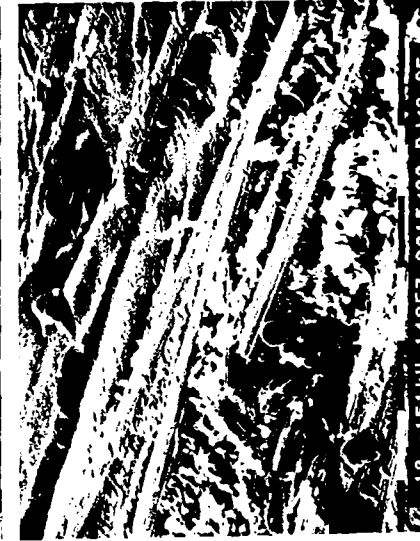
Right: 1170 thermal cycles,

$$G_{ult.} = 69 \text{ N/mm}^2.$$

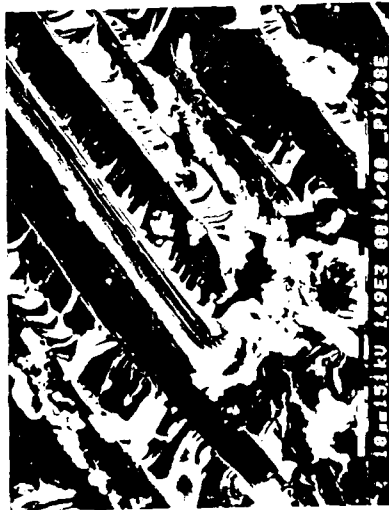
Fig. 13.36

Polyimide laminates T3T-F178, $[\pm 45^\circ]$ _{2s}.
Left: Without thermal cycling,

$$\sigma_{ult.} = 121,5 \text{ N/mm}^2.$$

of Figs. 13.36 and 13.37, on the other hand, points to a state of embrittlement in the polyimide-matrix on account of the high number of matrix cracks in the thermally cycled specimen.

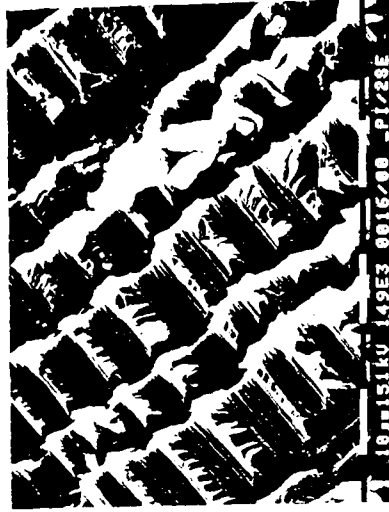
Fig. 13.37

Right: 1170 thermal cycles,

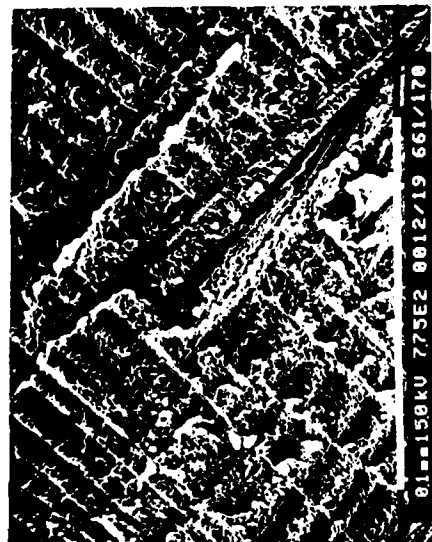
Fig. 13.39

H₁ =
1,5°C/min to
170°C;
170°C/4h

914C/T300 laminates [$\pm 45^\circ$]_s, with different curing cycles H₁ to H₄ (tensile test)

The fracture surfaces of specimens tensile-loaded to failure indicated subtle distinctions. Figs. 13.39 through 13.42 show microphotographs typical of the four curing cycles at a magnification of 775. It is apparent that the H_2 -cycle produced the most uniform fracture pattern. At a magnification of 3 100 (Fig. 13.43 through 13.46) certain differences in the microstructure of the epoxy resin are recognizable which become more obvious at still higher magnification (Figs. 13.47 through 13.50). In comparison to the H_2 -cycle, the sphere-shaped elements of the microstructure in the H_1 -cycle are less pronounced, of larger diameter and of a nonuniform distribution, while in the H_3 - and H_4 -cycles the microstructure appears molten and indistinct. Apparently the optimal formation of a spherical microstructure correlates with an optimal strength of the epoxy matrix.

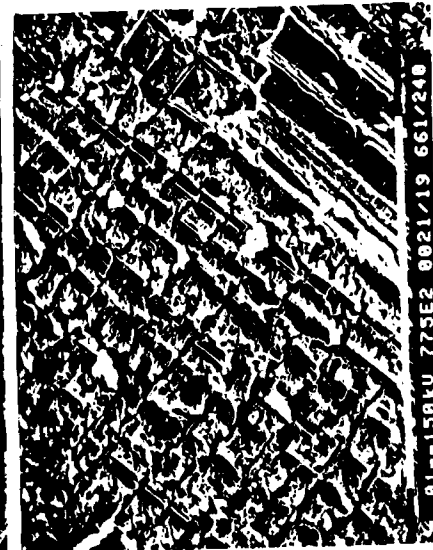
Fig. 13.41

H₃ =
H₂+240°C/4h

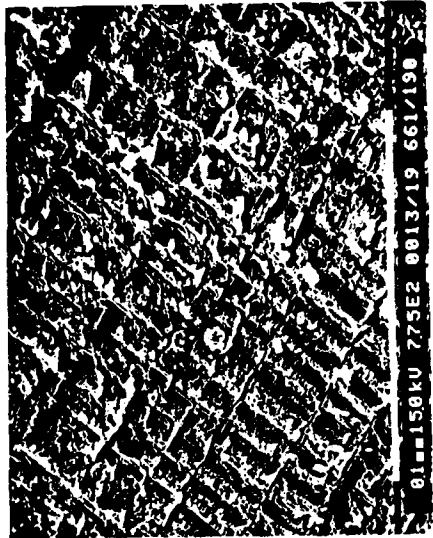
Fig. 13.40

H₂ =
H₁+190°C/4h

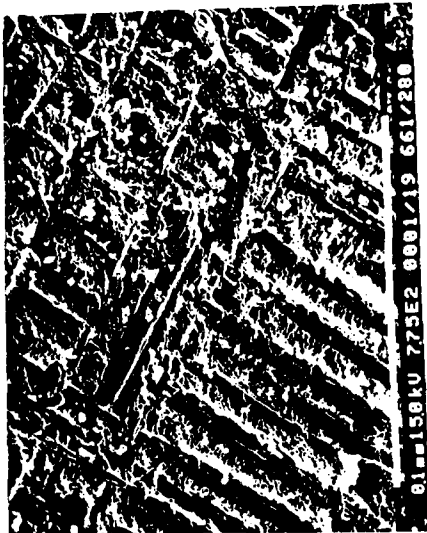
Fig. 13.42

H₄ =
H₃+280°C/2h

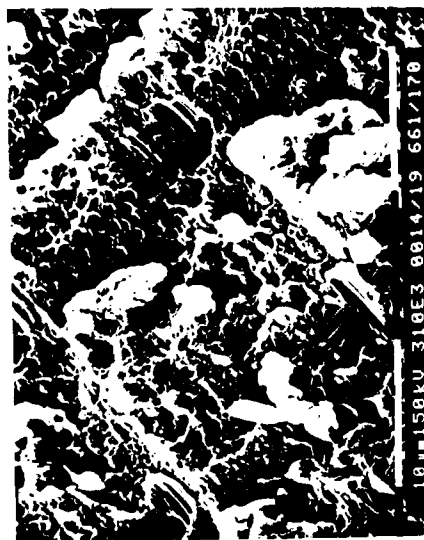
Fig. 13.43

$H_1 =$
 $1,5^\circ\text{C}/\text{min}$ to
 $170^\circ\text{C};$
 $170^\circ\text{C}/4\text{h}$

914C/T300 laminates $[\pm 45^\circ]_s$, with different curing cycles H_1 to H_4 (tensile test)

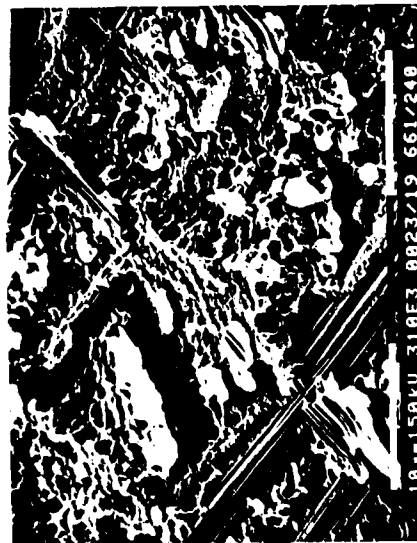
Fig. 13.45

$H_2 =$
 $H_2 + 240^\circ\text{C}/4\text{h}$

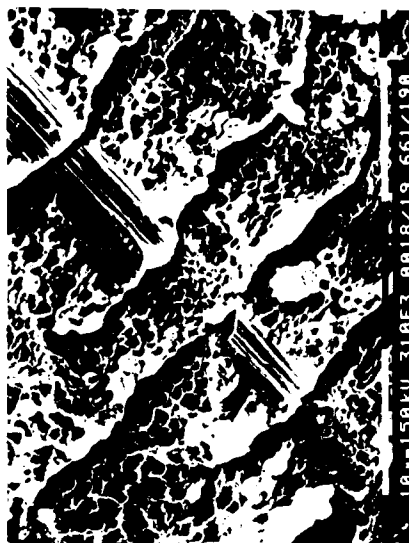
Fig. 13.44

$H_2 =$
 $H_1 + 190^\circ\text{C}/4\text{h}$

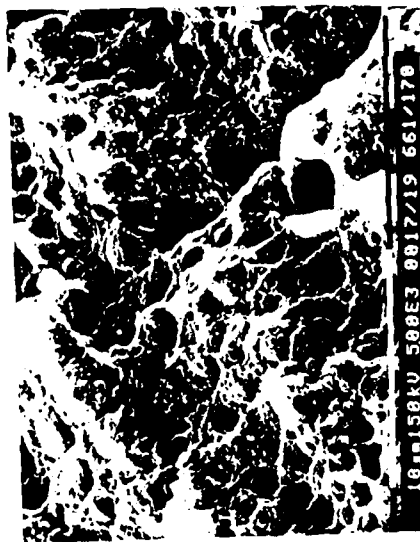
Fig. 13.47

$H_1 =$
 1,5°C/min to
 170°C;
 170°C/4h

914C/T300 laminates $[\pm 45^\circ]_s$, with different curing cycles H_1 to H_4 (tensile test)

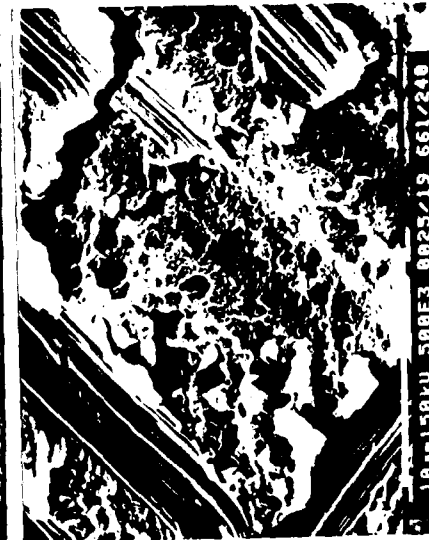
Fig. 13.49

$H_3 =$
 $H_2 + 240^\circ\text{C}/4\text{h}$

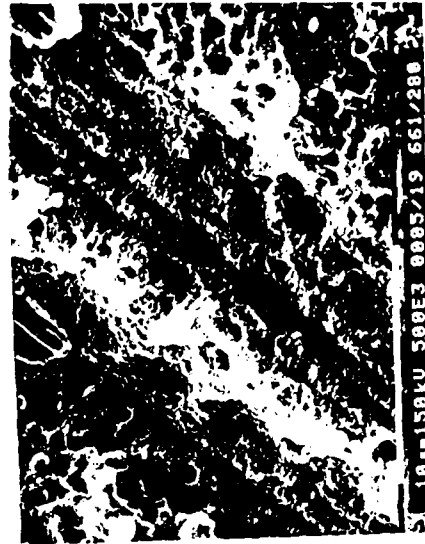
Fig. 13.50

$H_4 =$
 $H_3 + 280^\circ\text{C}/2\text{h}$

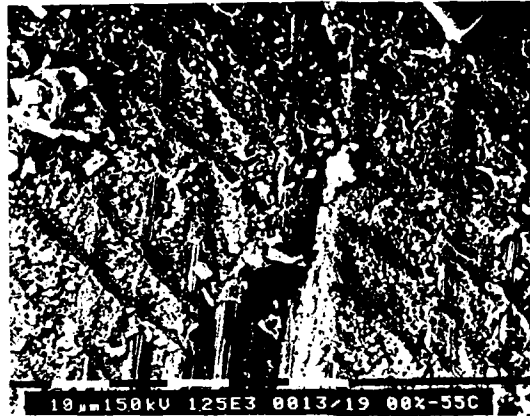
Fig. 13.51

$T = -55^{\circ}\text{C}$

Fracture surfaces of 914C/T300 laminates $[0^{\circ}, \pm 45^{\circ}, \overline{90^{\circ}}]_s$.
Tensile loading parallel to 0° -layer. View onto the
 90° -layer. Completely dry specimens, tested at different
temperatures.

The microphotographs in Figs. 13.51 through 13.58 display representative portions of the fracture surfaces of Fiberglass 914C T300 test specimens with a stacking order of $[0, \pm 45, 90]_g$. Two sets of test specimens were pre-conditioned to a completely dry state and to a moisture saturation state at 93% relative humidity, respectively, and then tension-loaded to failure at different temperatures. Figs. 13.51 through 13.53 depict the fracture characterization of the 90° -ply at the center of a dry specimen. It is quite evident that at -55°C the matrix material has a finely grained topography indicating low ductility whereas, beginning already at 25°C and clearly so at 120°C , the matrix fails with a coarser pattern and adheres less well to the fibers. This effect is more pronounced in the moisture-saturated specimen (Figs. 13.54 and 13.55) where, at 120°C , hardly any of the matrix material adheres to the fibers, signifying a predominantly adhesive failure. Rather similar observations can be made in Figs. 13.56 through 13.61 depicting corresponding appearances in a $\pm 45^\circ$ -ply.

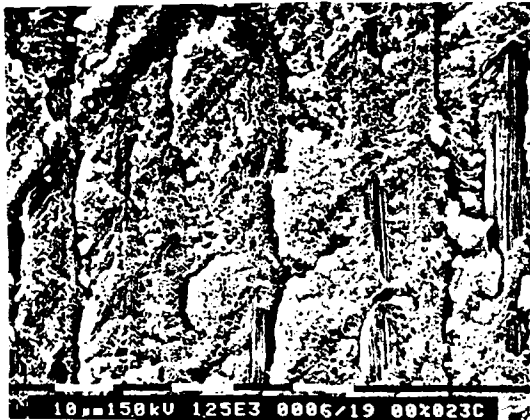
Fig. 13.52

$T = 23^{\circ}\text{C}$

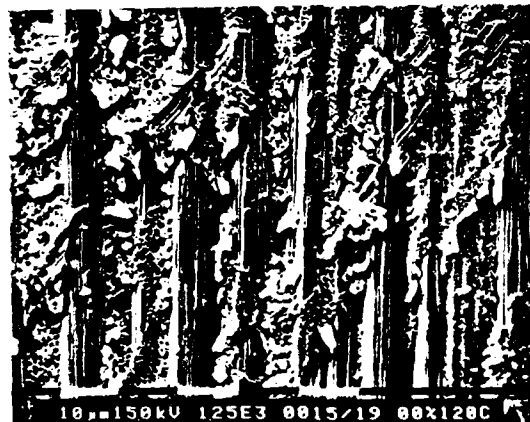
Fig. 13.53

$T = 120^{\circ}\text{C}$

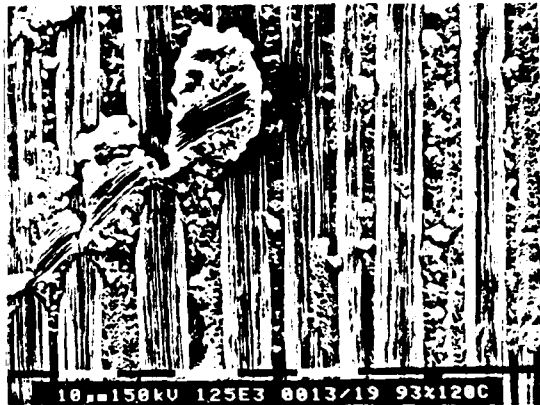
Fig. 13.55

$T = 120^{\circ}\text{C}$

Fracture surfaces of 914C/T300 laminates $[0^{\circ}, \pm 45^{\circ}, \overline{90^{\circ}}]_s$.
Tensile loading parallel to 0° -layer. View onto the
 90° -layer. Moisture saturated specimens (at 93% r.H.),
tested at different temperatures.

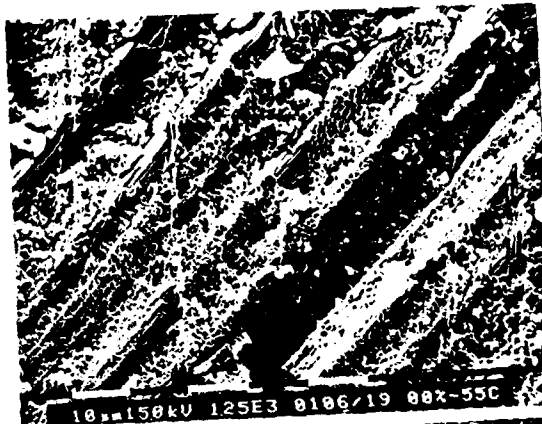
Fig. 13.56

$T = -55^{\circ}\text{C}$

Fracture surfaces of 914C/T300 laminates $[0^{\circ}, \pm 45^{\circ}, \overline{90^{\circ}}]_s$. Tensile loading parallel to 0° -layer. View onto the $+45^{\circ}$ -layer. Completely dry specimens tested at different temperatures.

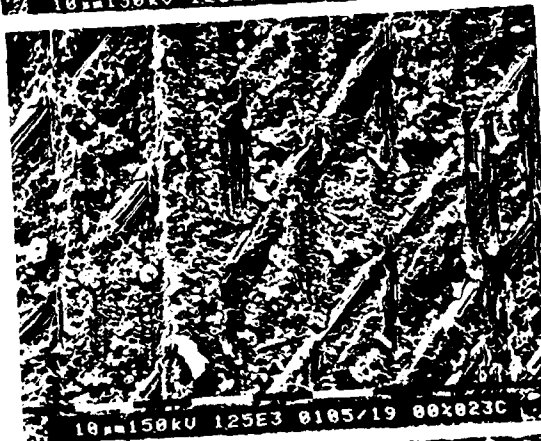
Fig. 13.57

$T = 23^{\circ}\text{C}$

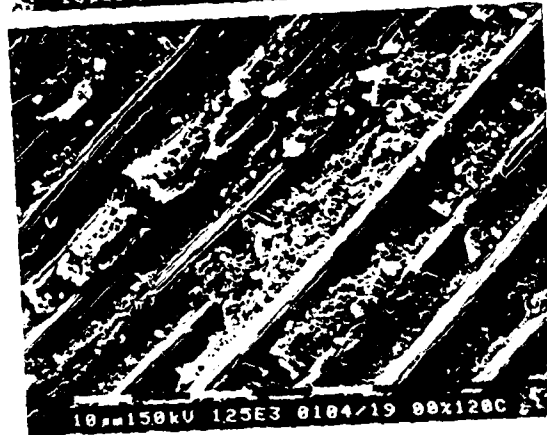
Fig. 13.58

$T = 120^{\circ}\text{C}$

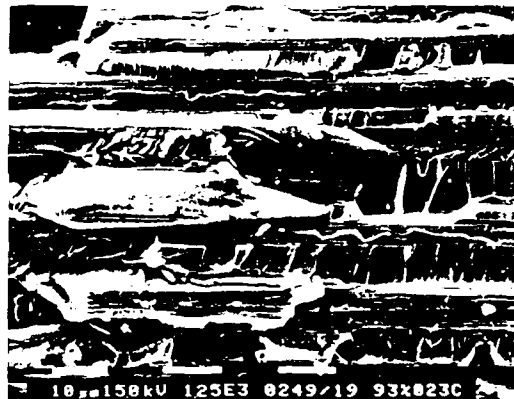
Fig. 13.72

Fracture surfaces of unidirectional Code 6/T300 laminates. Tensile loading transverse to fiber direction. Completely dry specimens tested at different temperatures.

$T = 23^{\circ}\text{C}$

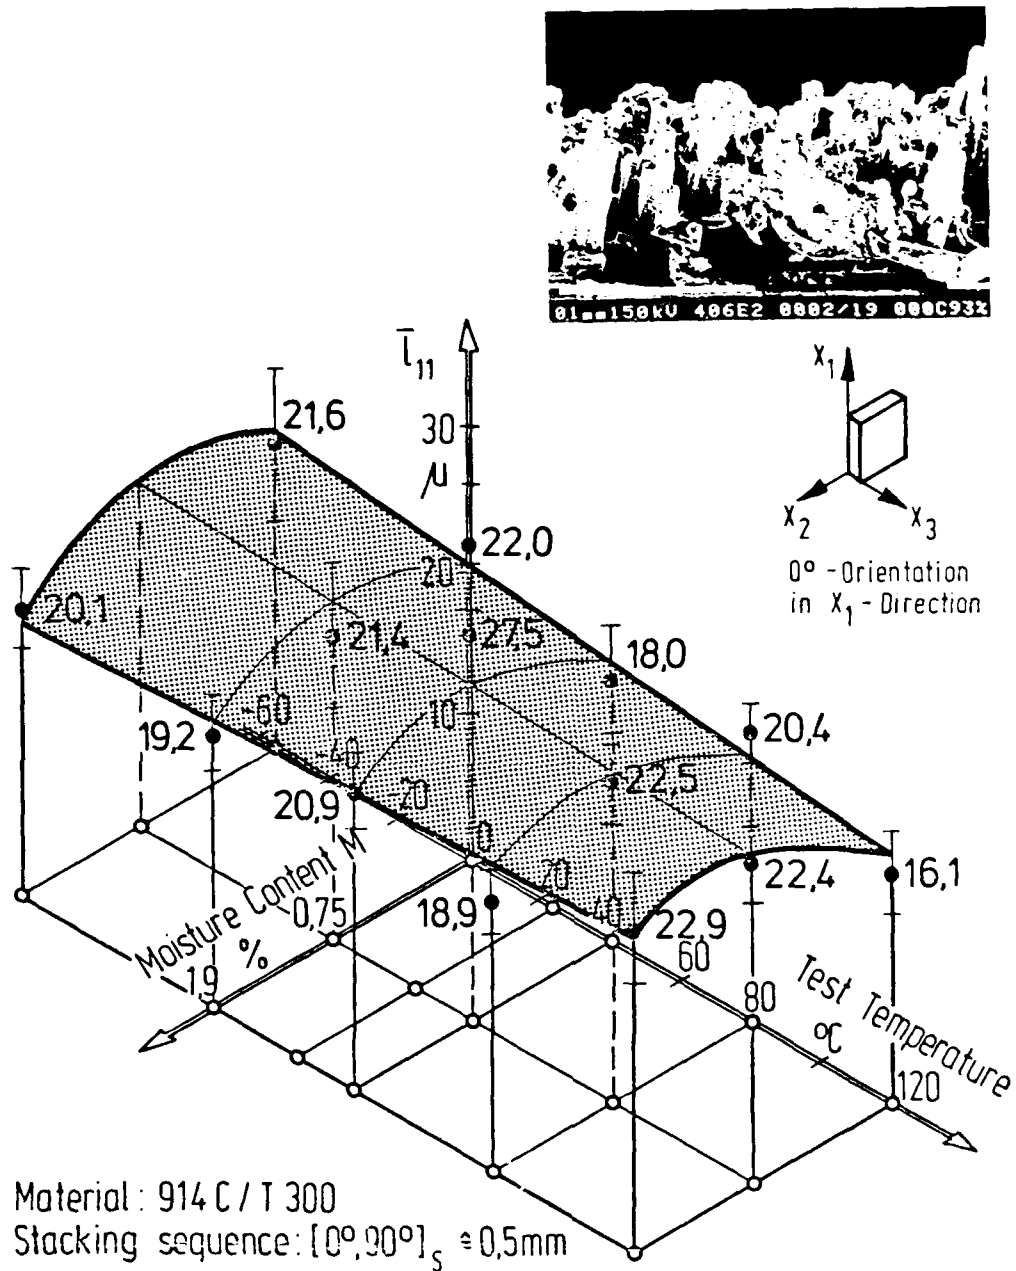
Fig. 13.74 Mean length of fiber pull-out \bar{l}_{11} of 914C/T300-laminates $[0^\circ, 90^\circ]_s$ as a function of test temperature and material moisture content.

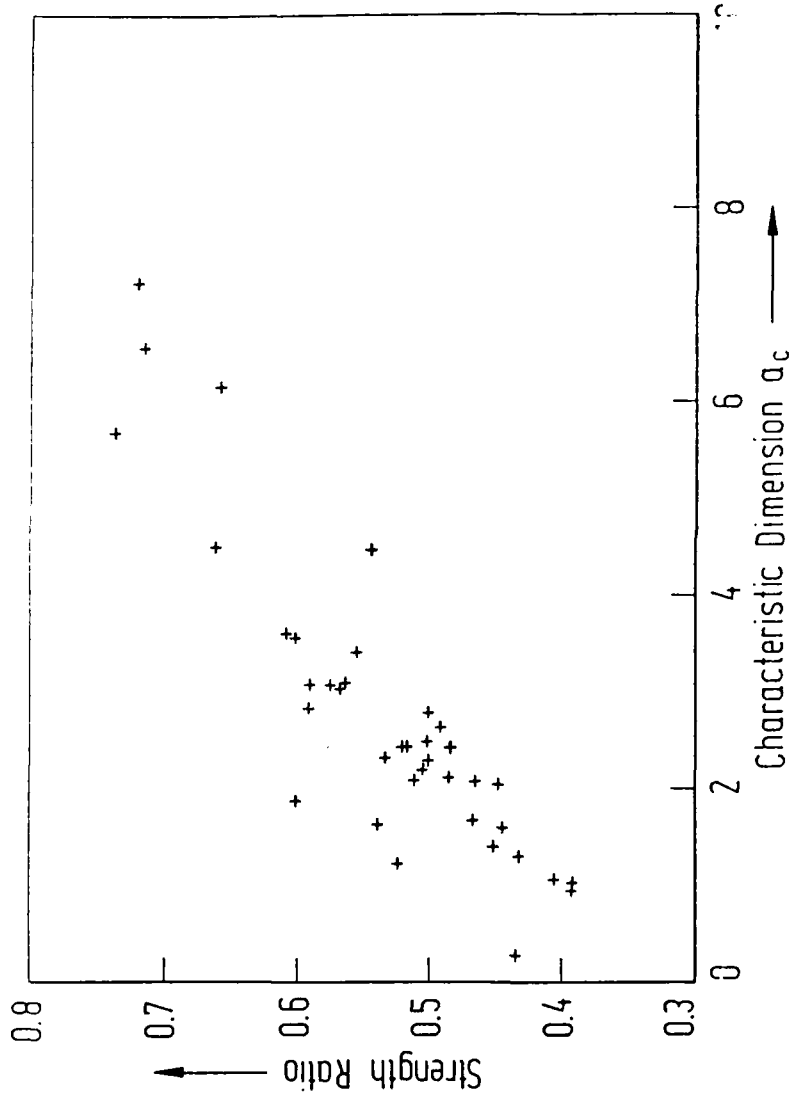
Fig. 15.2 Correlation between notched strength ratio and characteristic dimensions, a_c , (WEK-fracture model) for graphite/epoxy laminates containing circular holes ($2R/W = 0.25$).

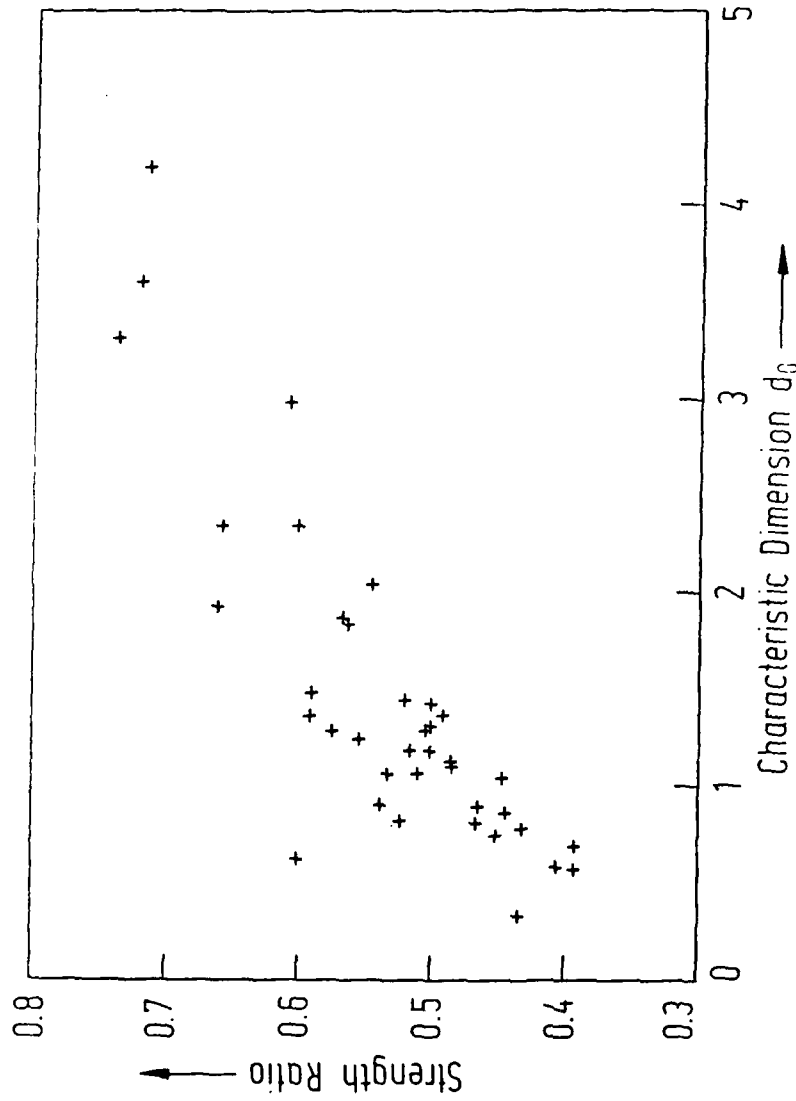
Fig. 15.3 Correlation between notched strength ratio and characteristic dimension, d_0 , (WN-fracture model, "point stress" criterion) for graphite/epoxy laminates containing circular holes ($2R/W = 0.25$).

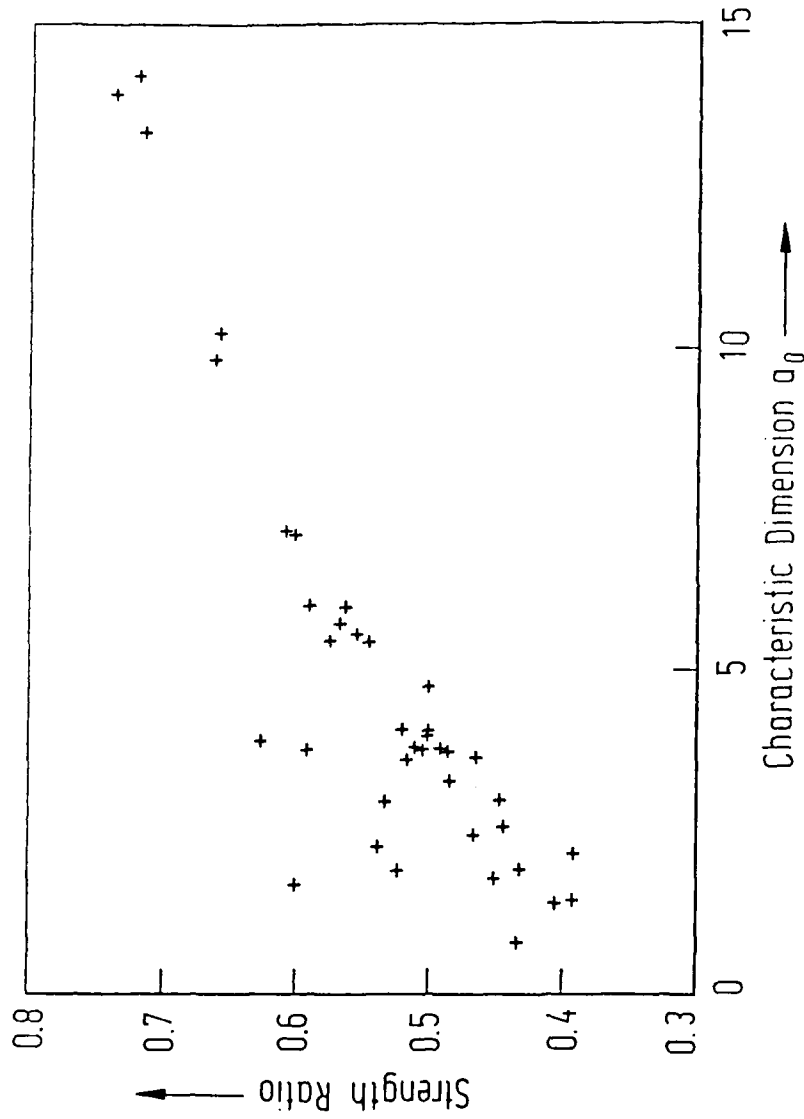
Fig. 15.4 Correlation between notched strength ratio and characteristic dimension, a_0 , (WN-fracture model, "average stress" criterion) for graphite/epoxy laminates containing circular holes ($2R/W = 0.25$).
